INVESTIGATION REPORT

CASE NUMBER: 17CALNU010045

CASE NAME: Tubbs

INCIDENT TYPE: Wildland Fire

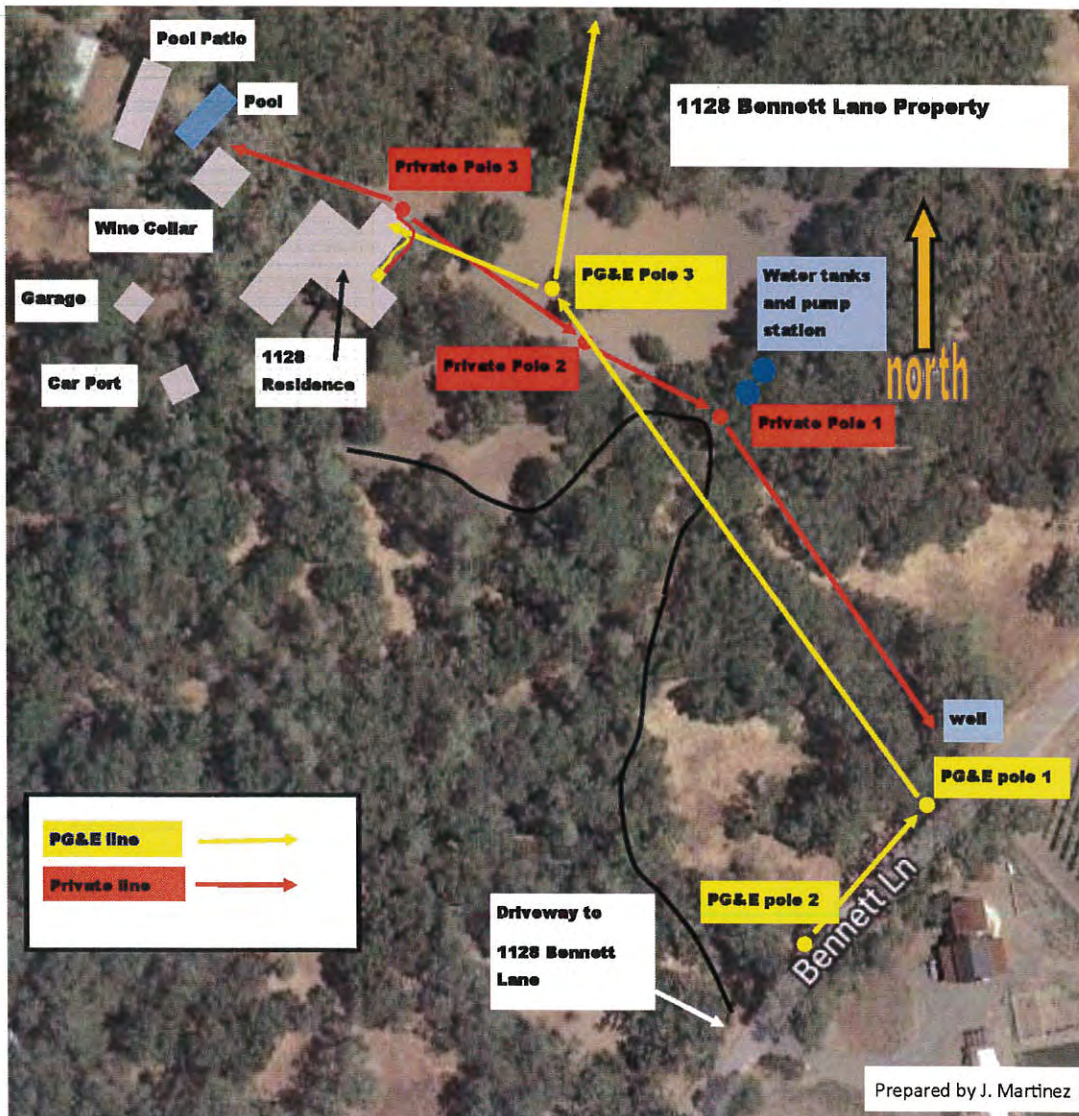
1 privately-owned power pole (private pole 3). From private pole 3, conductor extends
2 north west towards the wine cellar and pool patio. Additionally, from private pole 3,
3 conductor extends southeast towards private pole 2, then to private pole 1 where the
4 water tanks and pump station are located. From private pole 1, conductor extends
5 downhill where it ties into a well next to Bennett Lane. The graphic below includes a
6 general representation of the developed property at 1128 Bennett Lane with a general
7 schematic of the electrical system.
